HUNTER VALLEY OPERATIONS

2022 ANNUAL ENVIRONMENTAL REVIEW

DOCUMENT NUMBER
HVOOC-748212775-6

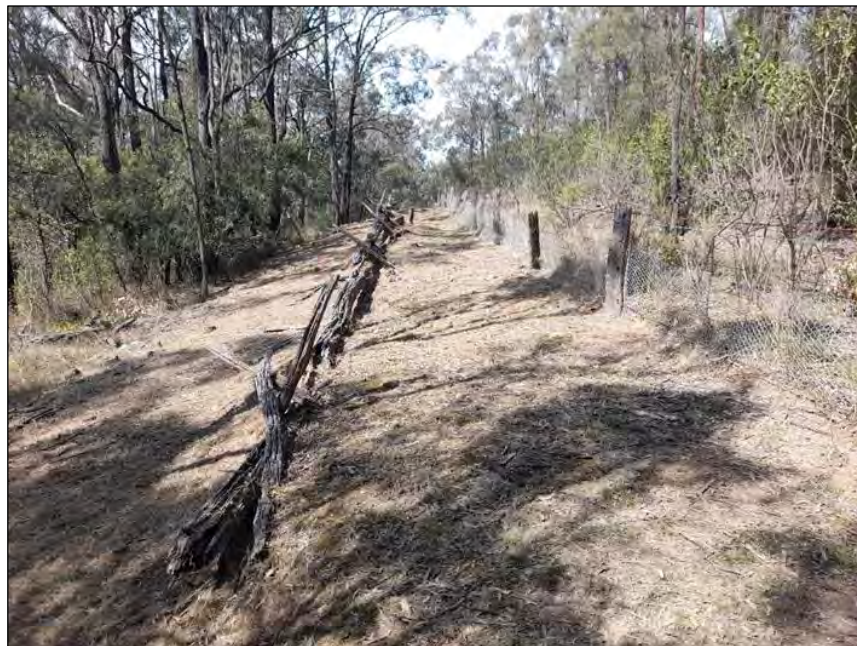
Figure 6-18: Cockatoo Fence Firebreak

- The Cockatoo Fence Asset Protection Zone maintenance works which were completed in August 2022 with the manual brushcutting of existing firebreaks on either side of the fence structure.

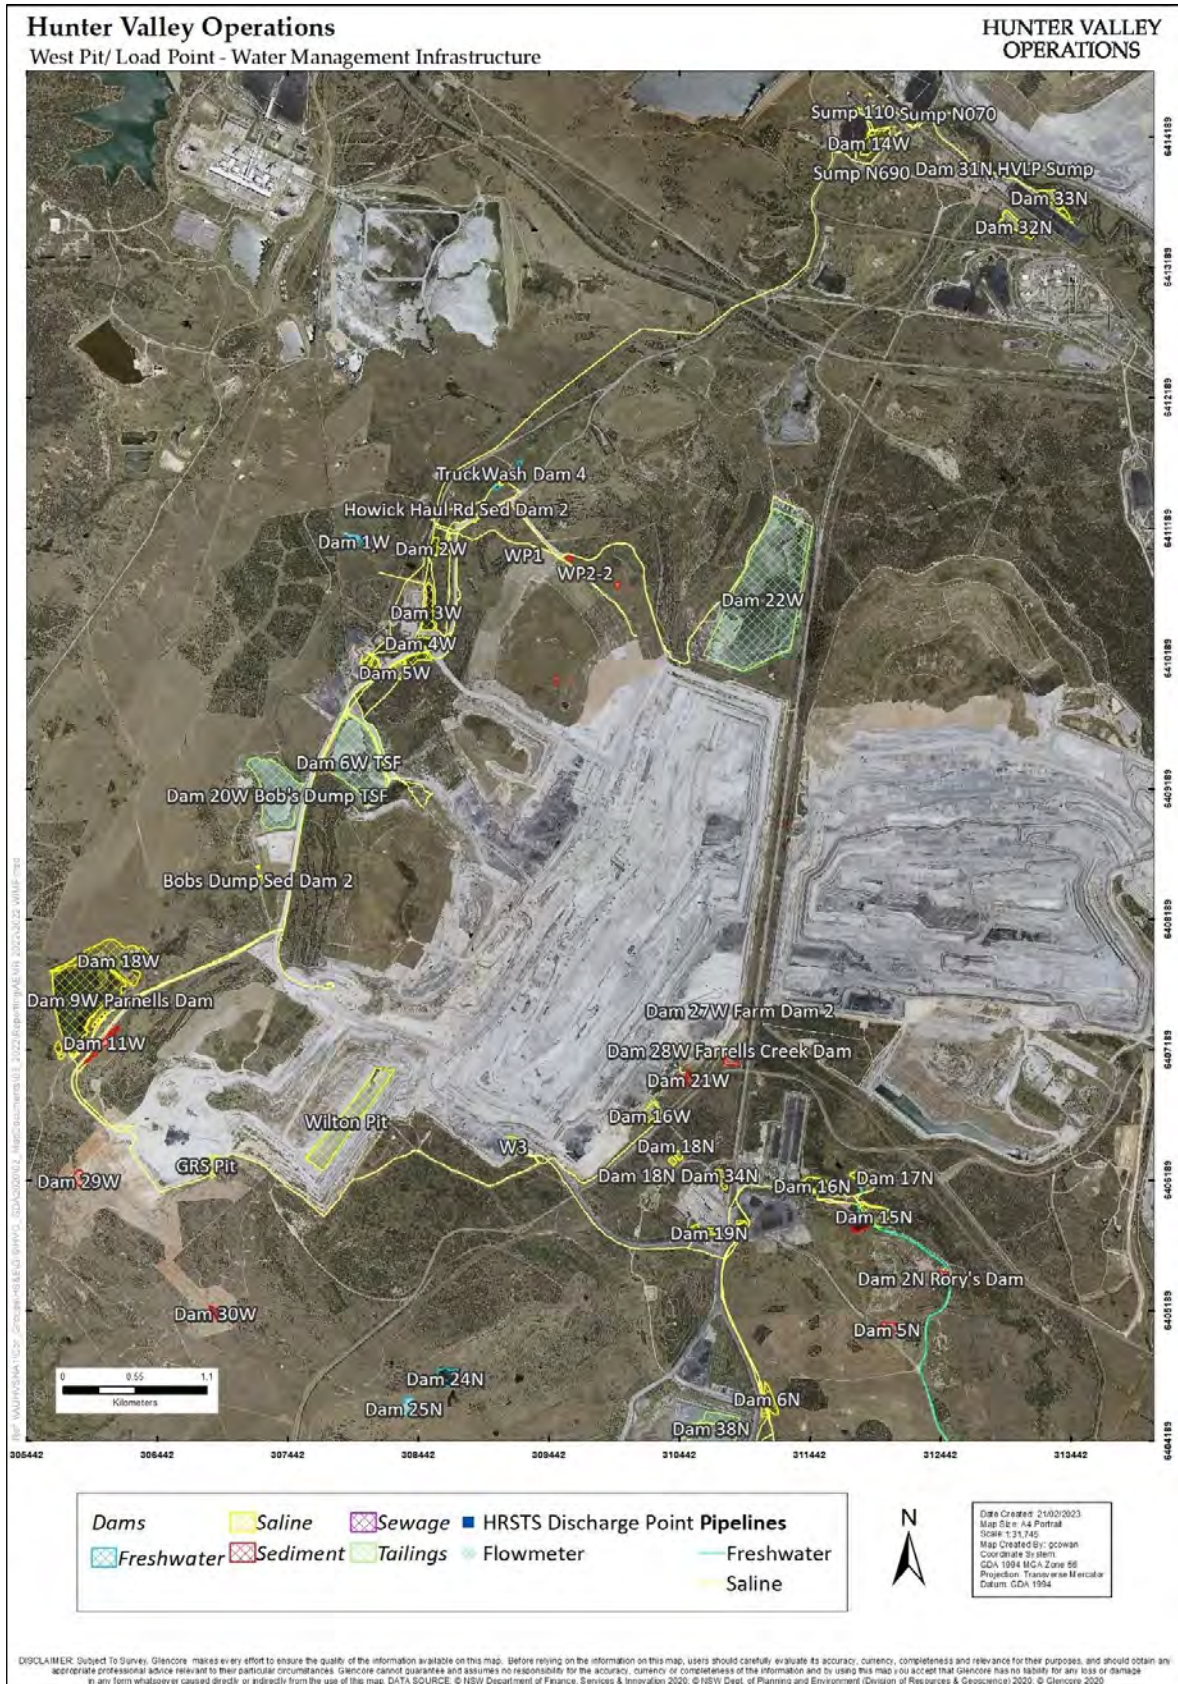
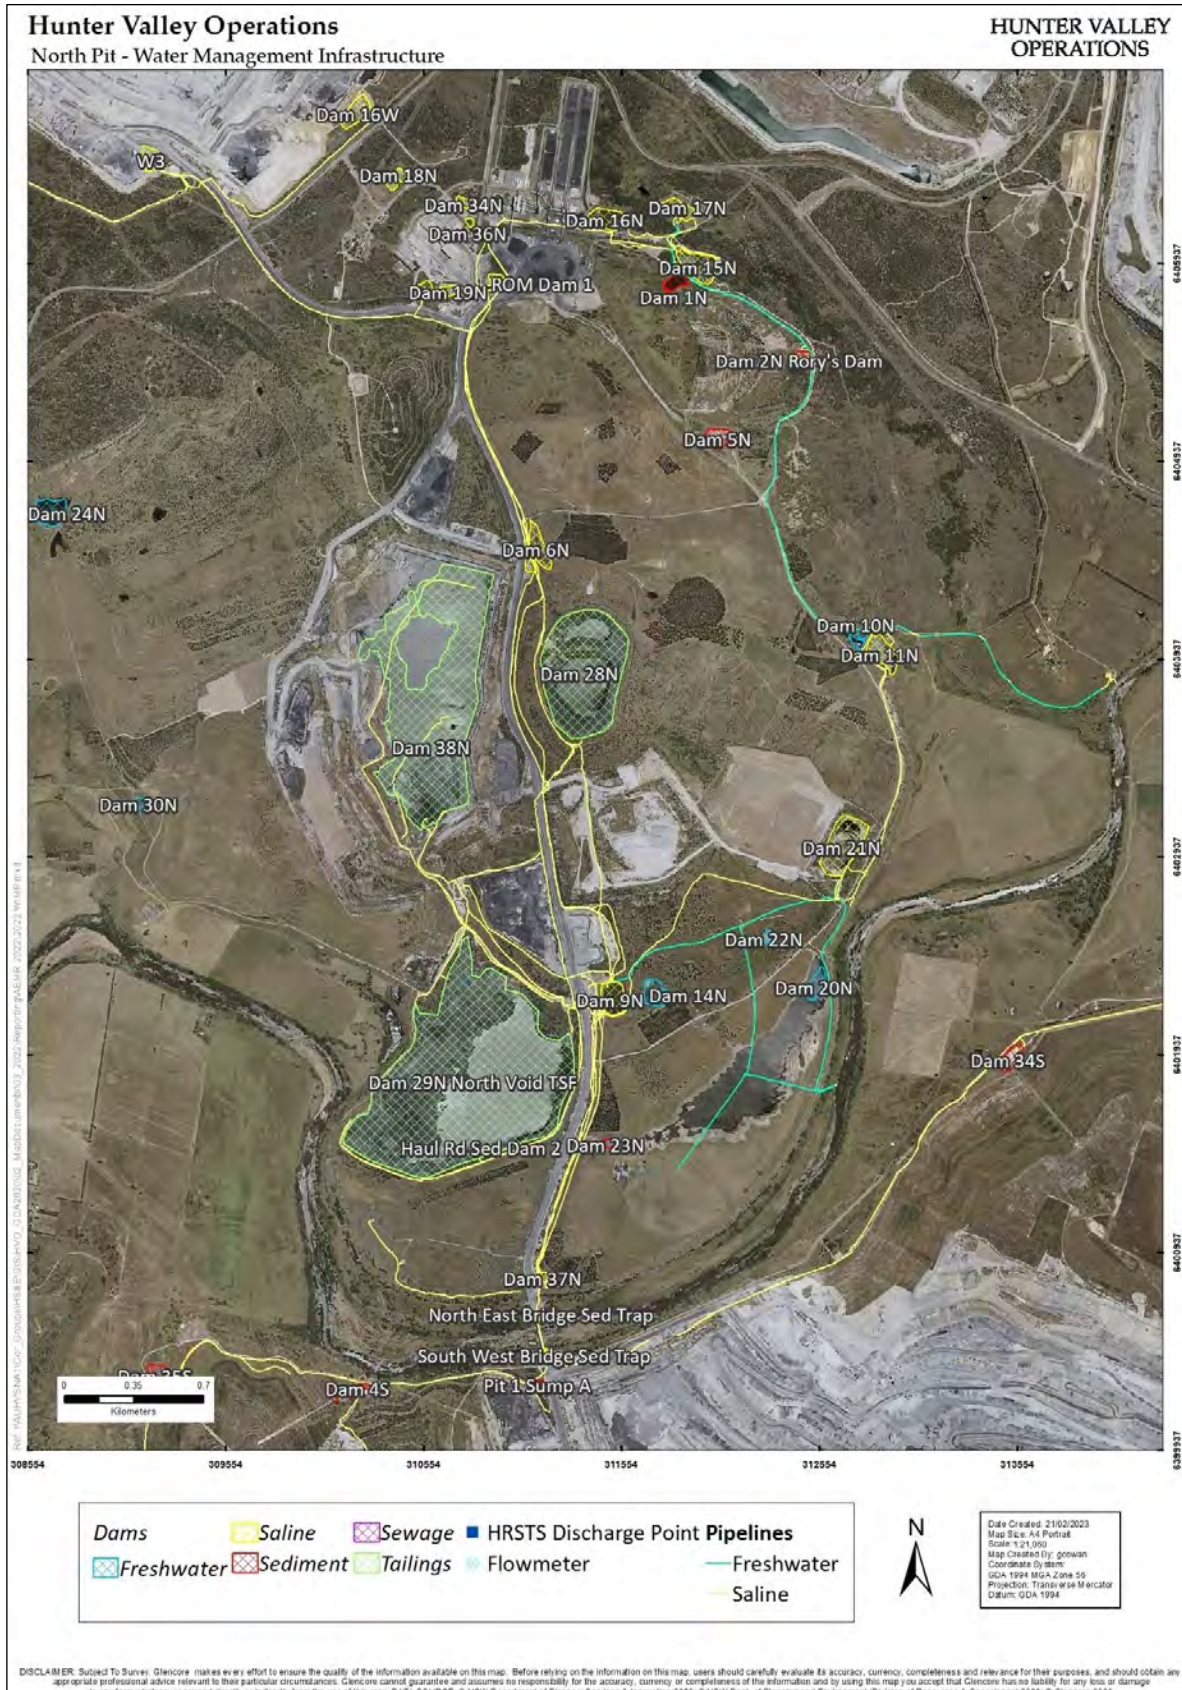
Plans showing the layout of all water management structures and key pipelines are shown in **Figure 7-1** to **Figure 7-3**. The HVO Water Management Plan contains further detail on management practices and is available on HVO website. Note that **Figure 7-1** to **Figure 7-3** are updated versions of plans presented in the currently approved *HVO Water Management Plan*, and have been included in the revised version of the plan provided to DPE for approval.

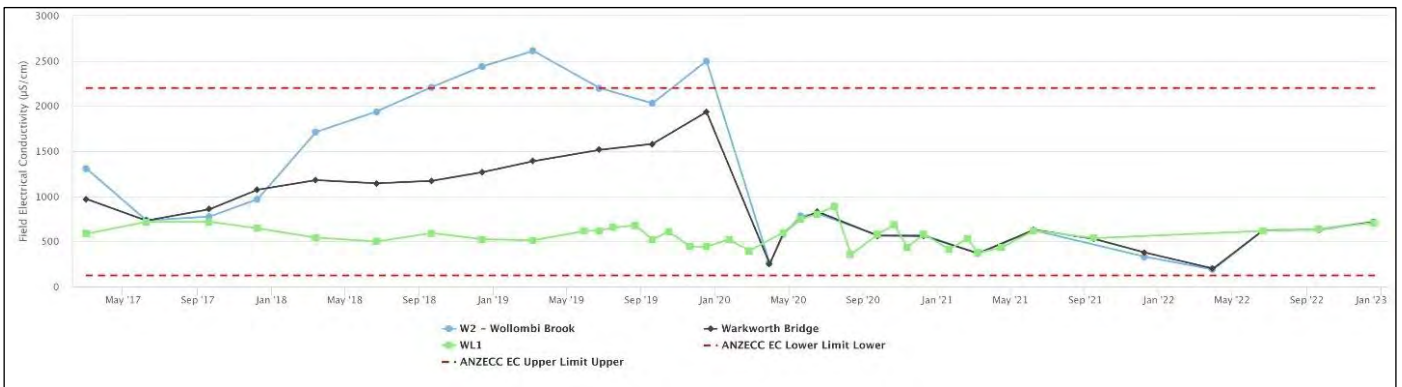
Wollombi Brook was sampled on 15 occasions from three monitoring locations during 2022. Long term trends for pH, EC and TSS from Wollombi Brook are shown in **Figure 7-8** to **Figure 7-10**.

Results were generally consistent with historical trends and acceptable ranges.

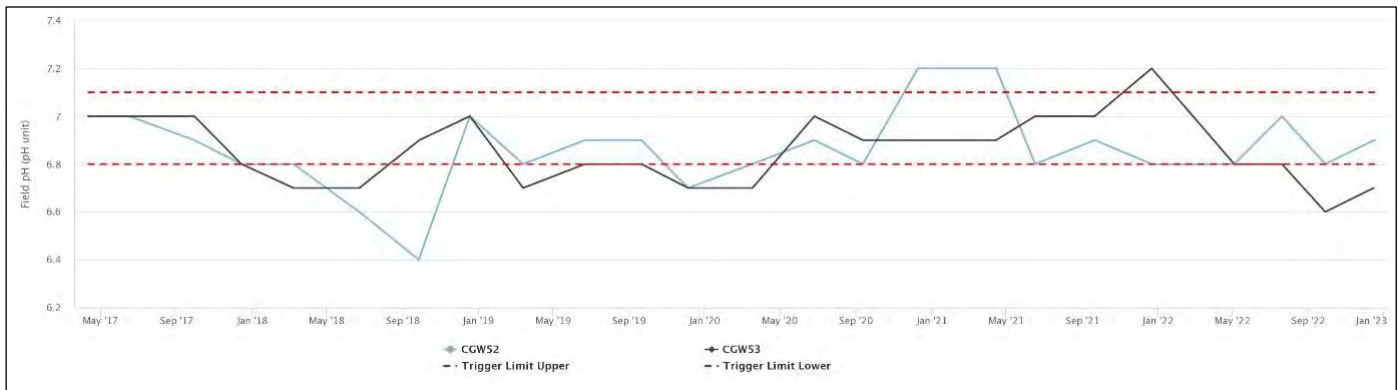
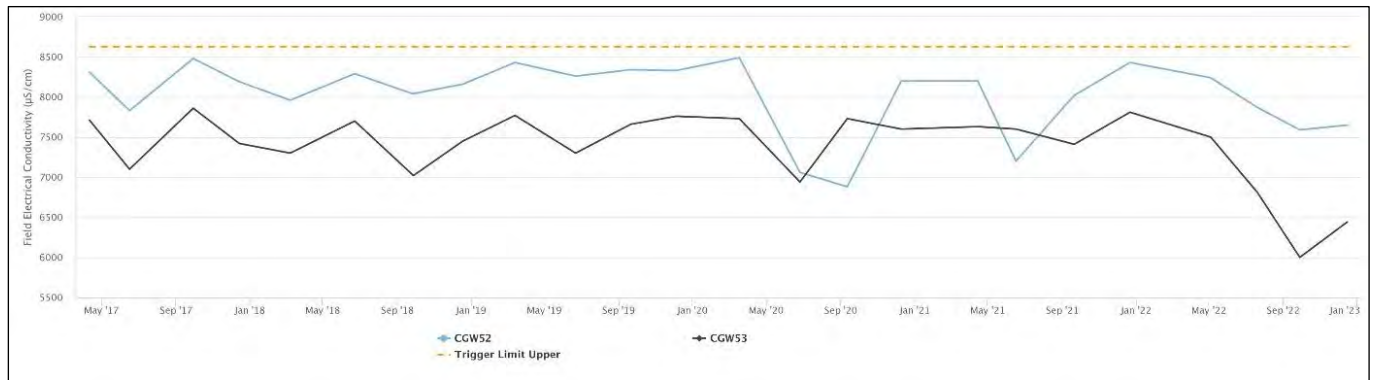
The EC, pH and SWL trends for 2017 to 2022 for Carrington Broonie Seam groundwater bores are shown in **Figure 7-19** to **Figure 7-21** respectively. Water quality results were generally consistent with historical ranges with some minor variation noted with pH and SWL results.

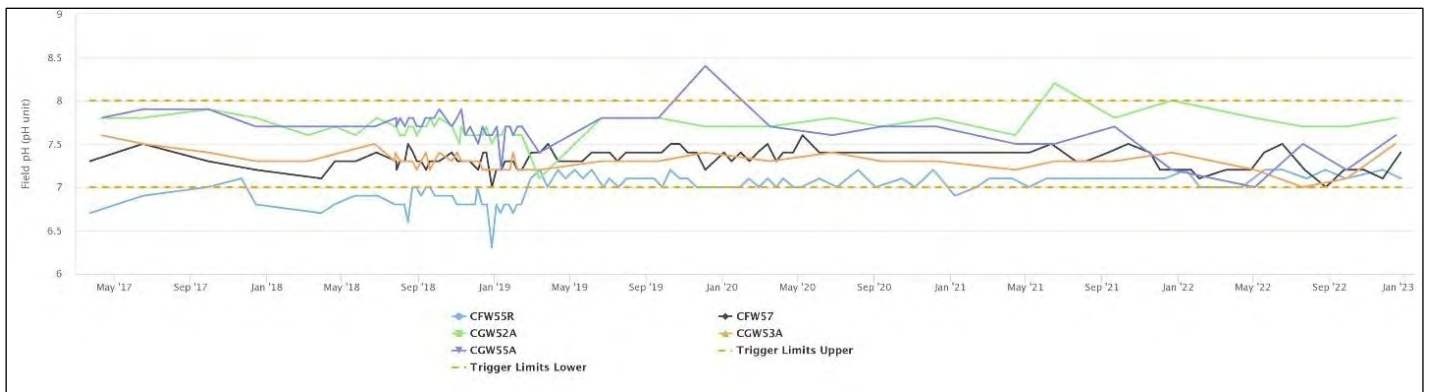
The EC, pH and SWL trends for 2017 to 2022 for Carrington Alluvium groundwater bores are shown in **Figure 7-22** to **Figure 7-24**. Water quality results were generally consistent with historical trends.

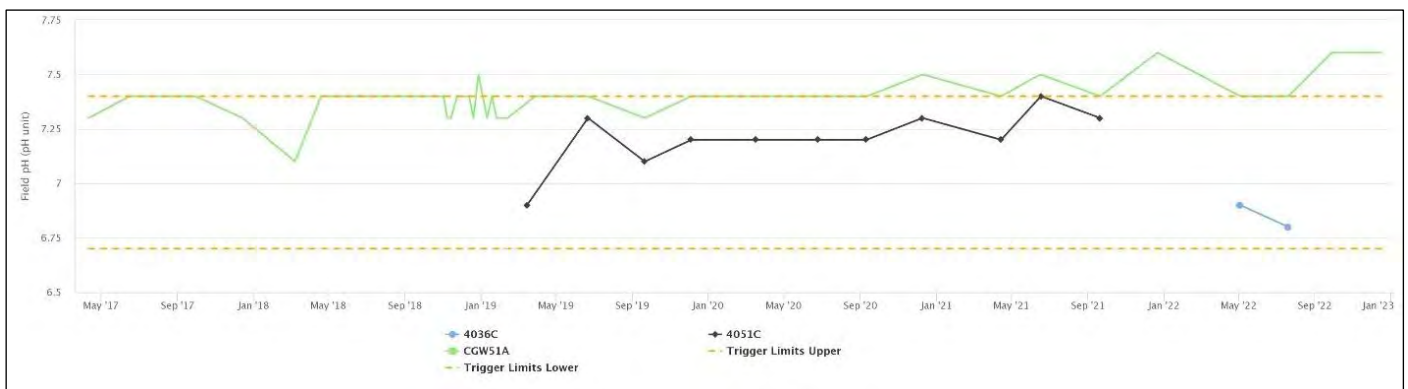
The EC, pH and SWL trends for 2017 to 2022 for groundwater bores in the Carrington Interburden are shown in **Figure 7-25** to **Figure 7-27** respectively. Water quality results were generally consistent with historical trends. Bore 4036C was dry and therefore samples were unable to be collected during 2022.

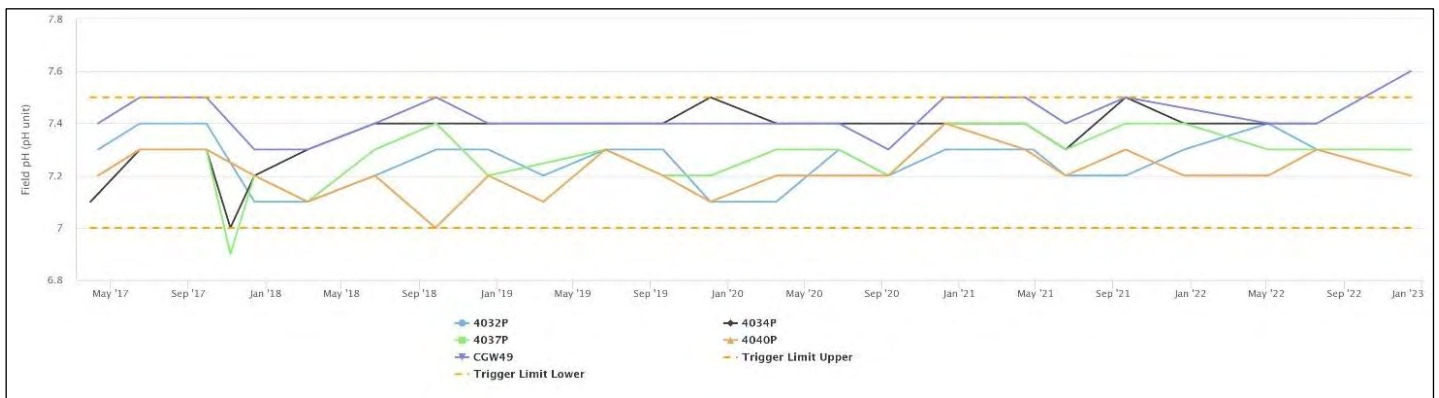
Results are shown in **Figure 7-28** to **Figure 7-30**. Water quality results were generally consistent with historical trends. Bore CGW49 intersects alluvium within the western limb of the paleochannel. Historical readings show that bore CGW49 has recorded pH ranging between 6.6 and 8.1. Review of pH readings remained fairly stable and within historical levels over 2022. The results show no adverse impacts due to mining.

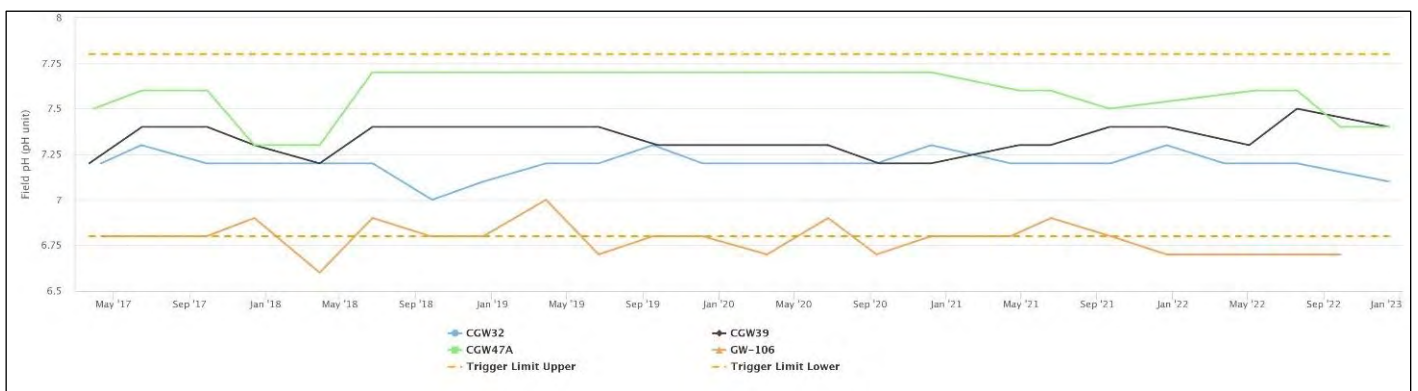
Results are shown in **Figure 7-31** to **Figure 7-33**. Water quality results were generally consistent with historical trends. pH levels for GW-106 were slightly below the lower pH trigger for Q1 to Q3 2022. This bore has been removed in the revised Version 3.4 of the Water Management Plan that has been submitted to DPE for approval.

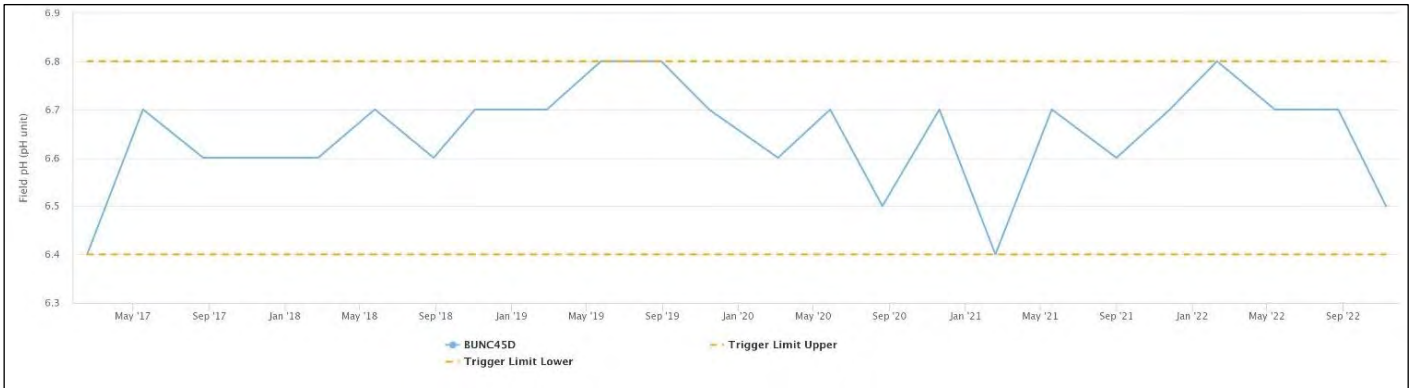
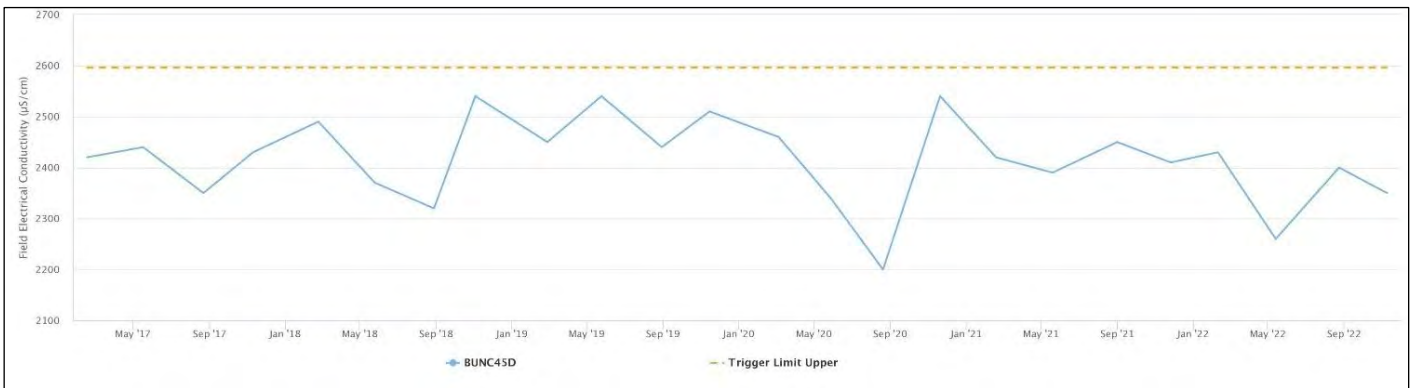
The pH, EC and SWL trends for 2017 to 2022 are shown in Figure 7-43 to Figure 7-45. Water quality results were generally consistent with historical trends.

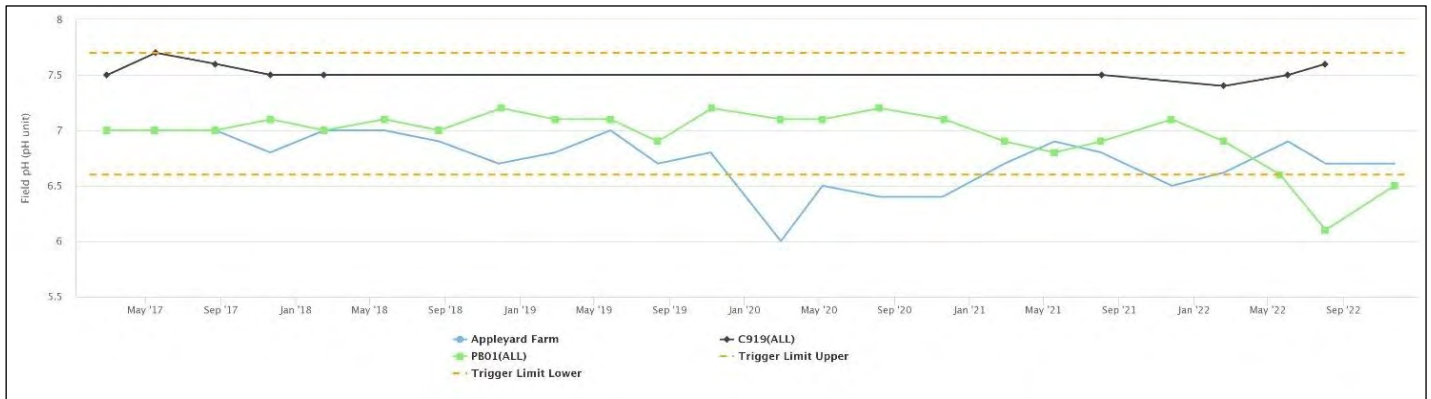
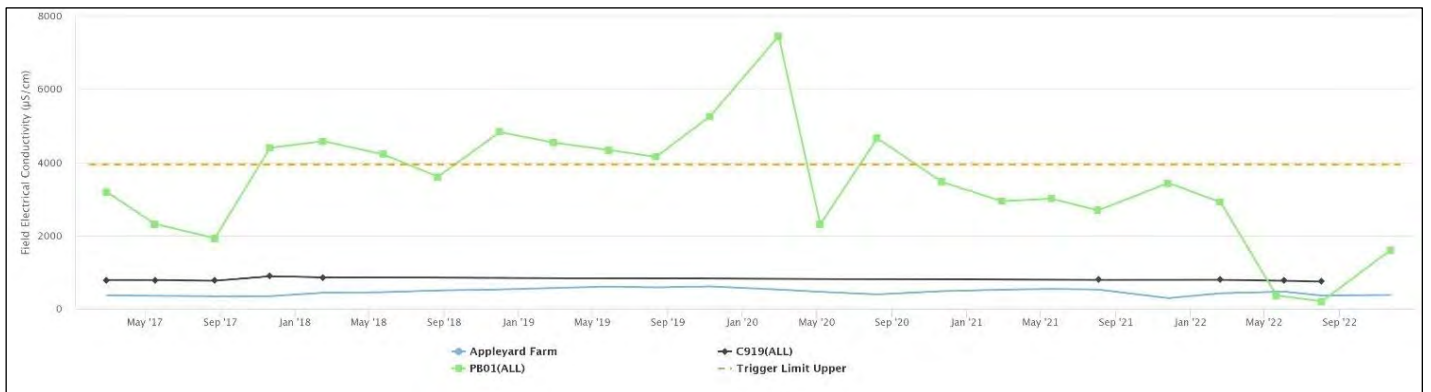
The pH, EC and SWL trends for 2017 to 2022 are shown in **Figure 7-46** to **Figure 7-48**. Water quality results were generally consistent with historical trends.

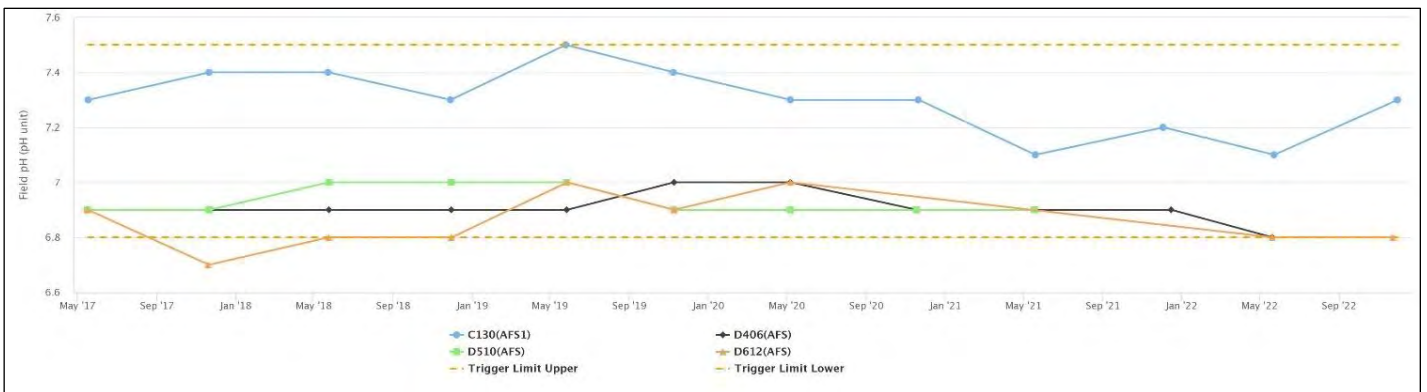
The pH, EC and SWL trends for 2017 to 2022 are shown in **Figure 7-49** to **Figure 7-51**. Water quality results were generally consistent with historical trends.

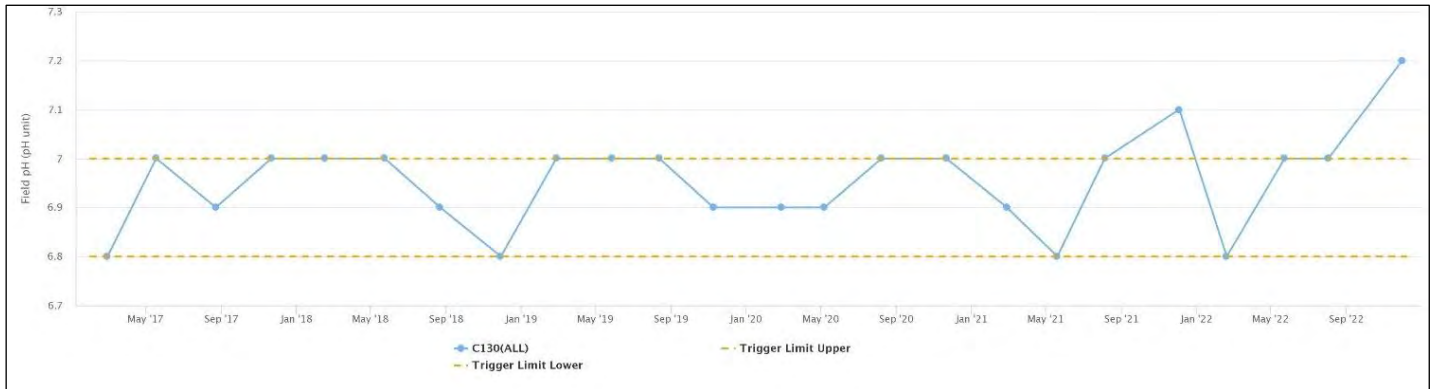
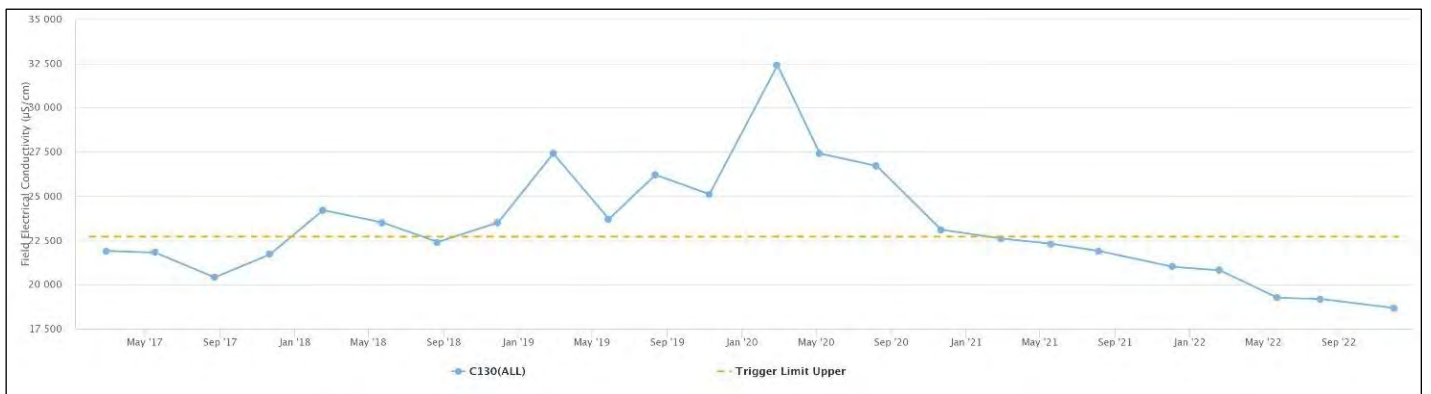
The pH, EC and SWL trends for 2017 to 2022 are shown in **Figure 7-55** to **Figure 7-57**. Historical readings of C130(ALL) show regular fluctuations of pH between 6.4 and 7.9 The 2022 readings for pH are considered consistent with historical concentrations. All of the EC measurements in the period 2011-2022 have exceeded the trigger value of 11,408 $\mu\text{S}/\text{cm}$. Therefore, the EC trigger value for the Lemington South – Interburden is not considered appropriate to assess the potential impact of approved mining activity on groundwater at this bore location. EC values were consistently reported between 20,000 and 22,000 $\mu\text{S}/\text{cm}$ from 2011 to 2017 and followed an increasing trend from 2018 to early 2020 reaching a maximum of 32,400 $\mu\text{S}/\text{cm}$ in February 2020 as reported in previous annual groundwater reviews.

A downward trend has been observed since early 2020, which coincides with a period of increased rainfall following the recent drought. In the updated draft WMP (HVO 2021), C130(ALL) has been reassigned to Lemington South – Overburden, and the EC trigger value is proposed to increase to 23,500 $\mu\text{S}/\text{cm}$.

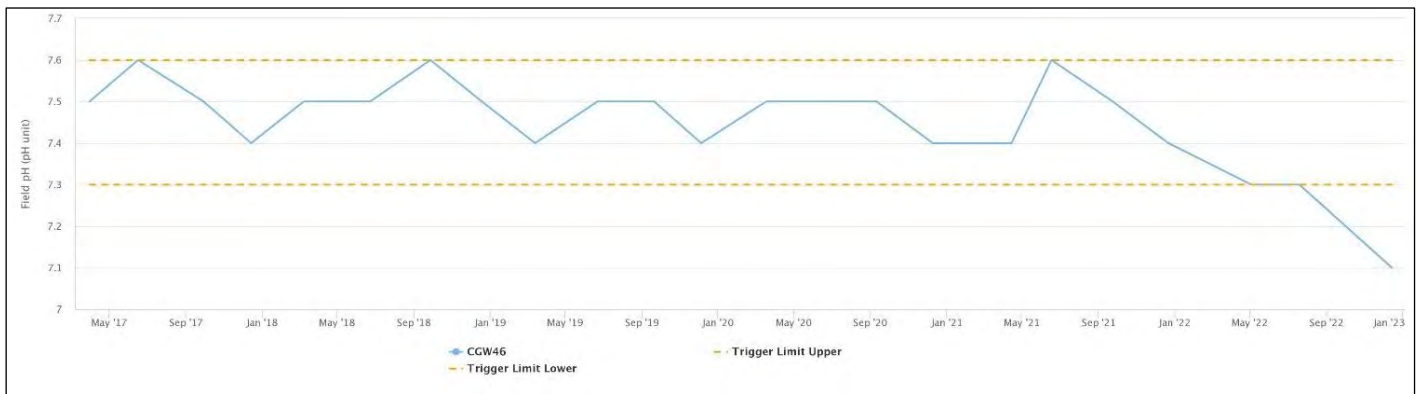
The pH, EC and SWL trends for 2017 to 2022 are shown in **Figure 7-73** to **Figure 7-75**. Water quality results were generally consistent with historical trends although there was a drop in EC and SWL.

Figure 7-73: Carrington West Wing Bayswater Groundwater pH Trends 2017 to 2022

Figure 7-74: Carrington West Wing Bayswater Groundwater EC Trends 2017 to 2022

Figure 7-75: Carrington West Wing Bayswater Groundwater SWL Trends 2017 to 2022

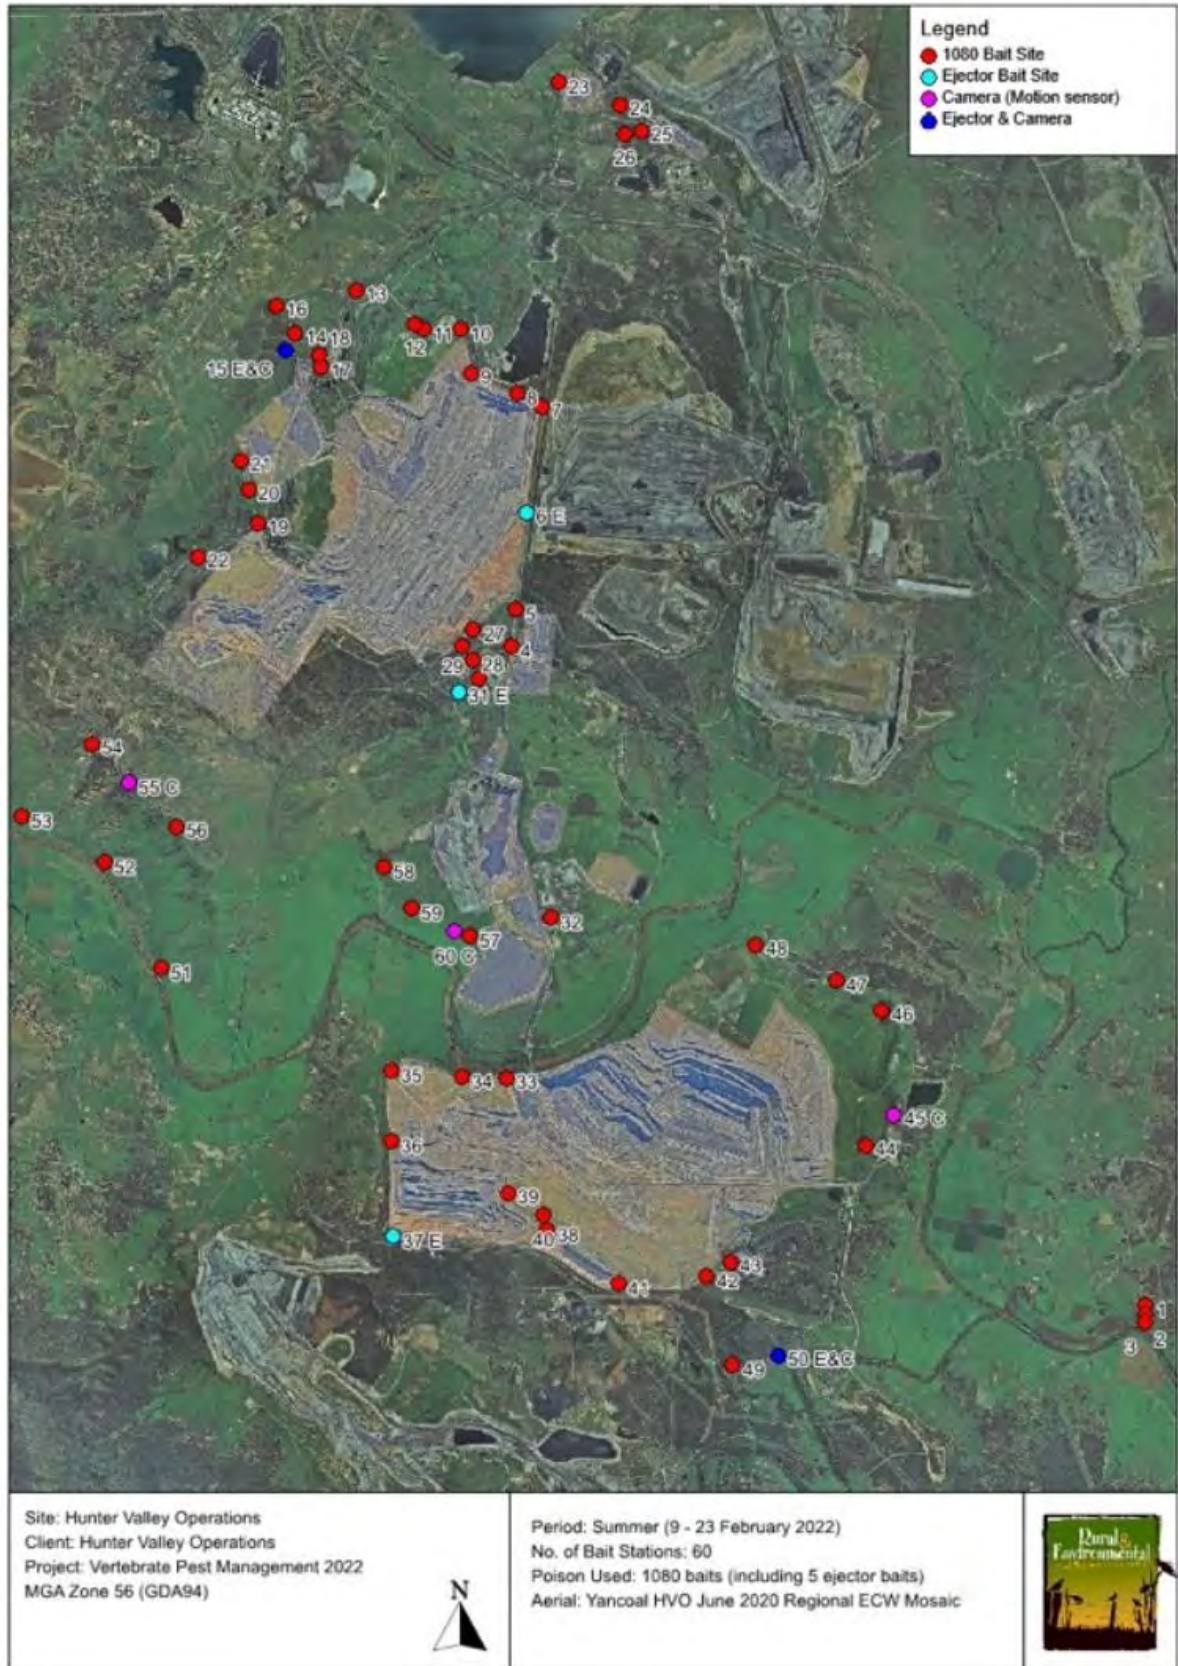
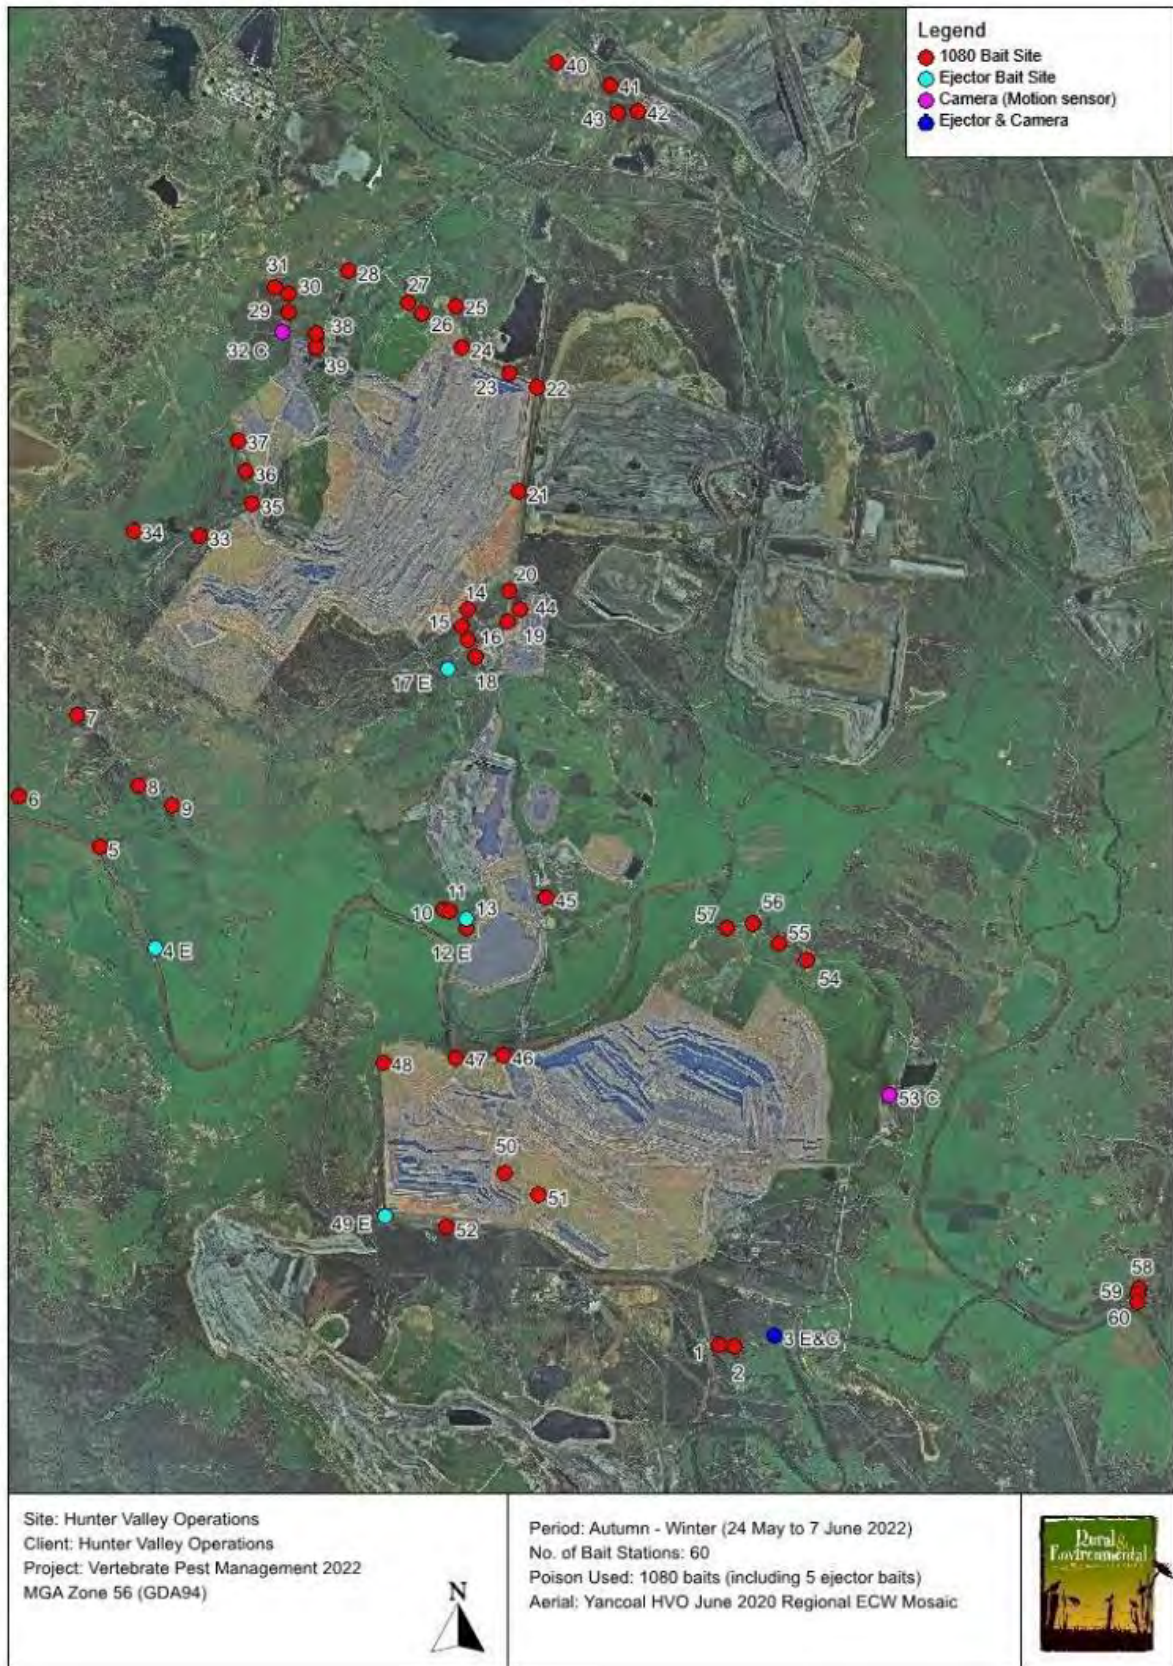
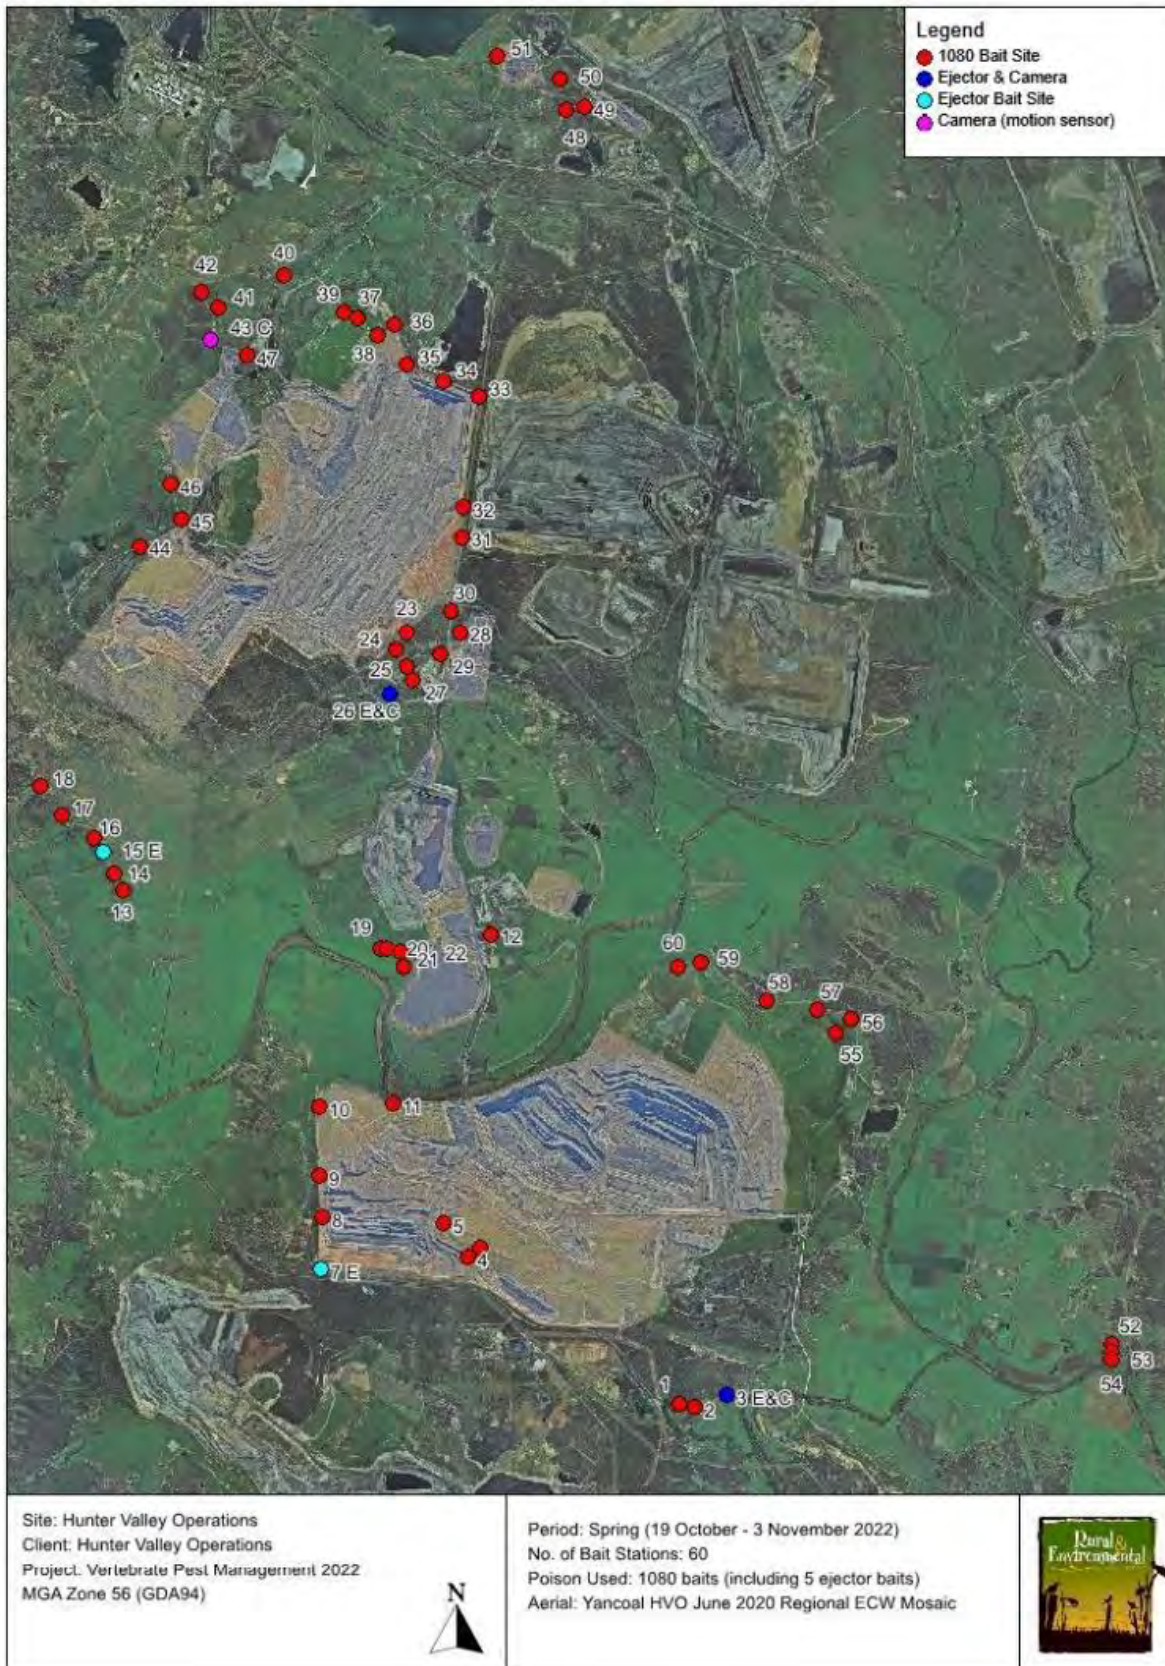
Figure 8-7: HVO Vertebrate Pest Management Bait Locations – Summer 2022

Figure 8-8: HVO Vertebrate Pest Management Bait Location – Autumn – Winter 2022

Figure 8-9: HVO Vertebrate Pest Management Bait Locations – Spring 2022

Table 8-10 summarises the results from the programmes carried out at HVO during 2022 with wild dog and fox baiting locations and results for the programs illustrated in Figure 8-7 to Figure 8-9.
